# Twist and Torque

**Wirerope Works, Inc.**

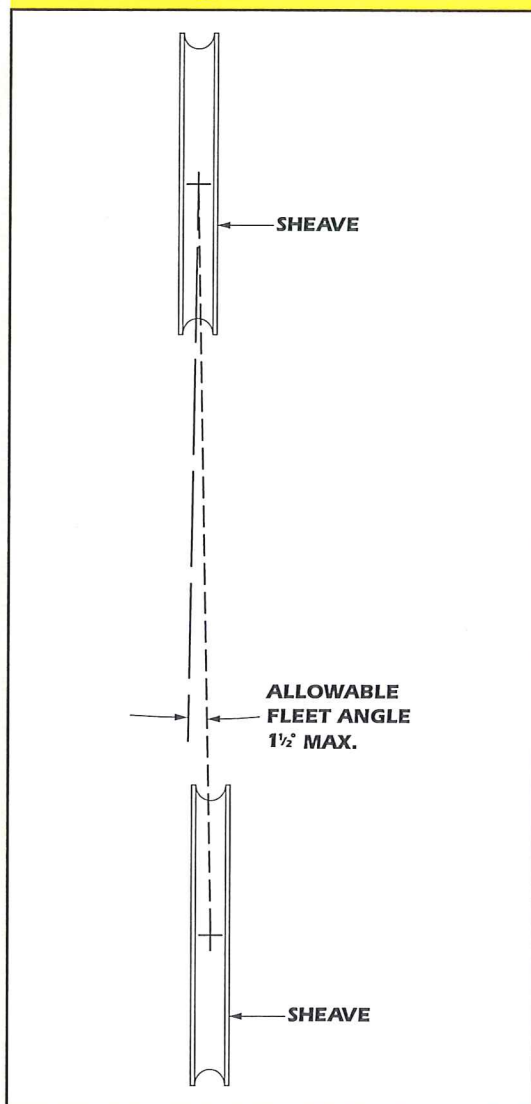
### Fleet Angle

Torquing of the ropes can also be caused by sheave misalignment and fleet angles in excess of  $1\frac{1}{2}$  degrees.
